KCE STRUCTURAL ENGINEERS, P.C.

August 30, 2013

RE: Westfield Montgomery Mall Westlake Garage
Gridlines 14 and 15 and C and D
Partial Precast Tee Collapse
Cause and Effect

Job No. 2013-10

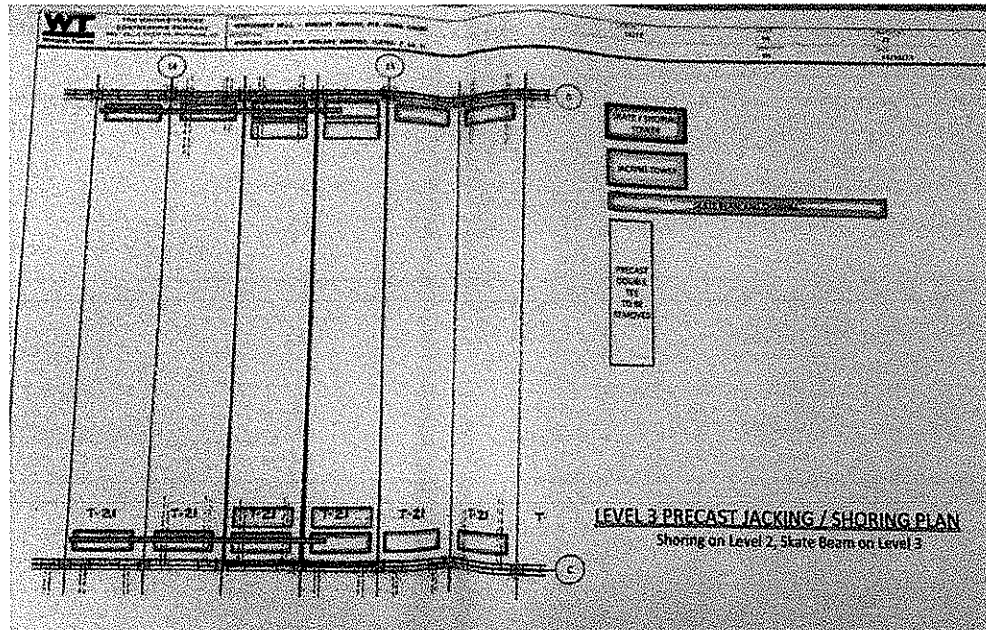
Figure 1 - WT Drawing Sheet J2 dated 05/05/13: Shoring Layout for Precast Removal (Level 2 to 3)

The WT Shoring/Jacking/Skating Procedure documents state the double tee was to be jacked 6" per increment using jacks supported on "jacking" towers in the configuration shown in Detail A on sheet J3 (exhibited in Figure 2 below). The towers rested on W6 runners directly on the Level 2 deck. The "safety" tower heads were raised as the jacking process proceeded to continuously support the load of the double tee. The jacks were then to be released to allow the precast load to "settle" on the "safety" shoring towers, the "jacking" towers' elevation adjusted, the jack reinstalled, and the steps repeated until the precast double tee was high enough to slide the tee over the adjacent double tees, which were to remain, to its temporary location.

The transverse W8x31's were placed snug to the bottom of the stem of the double tee and the double tee was jacked from the longitudinal W8x31 Jacking beam, shown in orange.

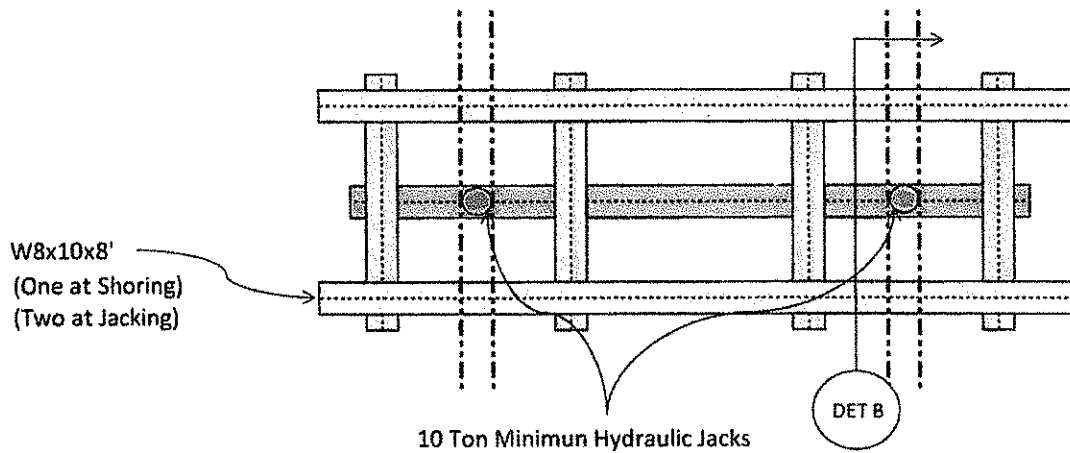
Figure 2 - WT Drawing Sheet J3 dated 05-05-13: "Jacking" Tower Configuration
(Color added by KCE.)

The "jacking" tower arrangement is configured so the longitudinal (low) W8x31 beam is bolted to the transverse W8x31's beams, securing its location. It is not likely that the load being applied to the transverse beams would be eccentric. Therefore, for our evaluation, we used a load on the transverse W8x31s equally distributed to the supporting legs of the AS25 base frames.

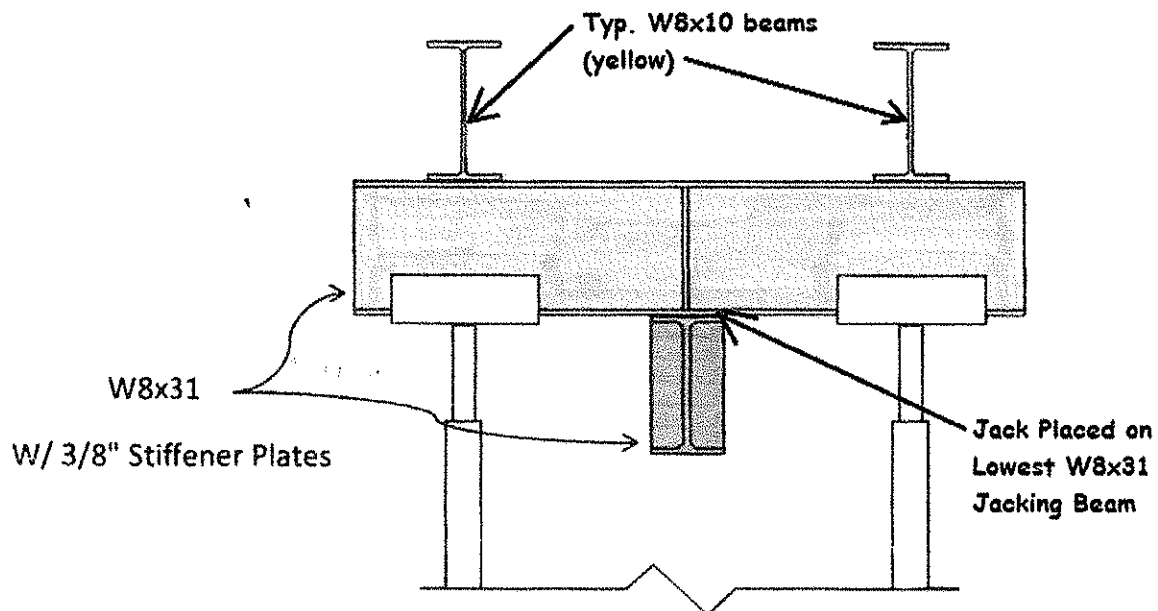
Figure 3 - WT Drawing Sheet J3 dated 05-05-13: Section of "Jacking" Tower Configuration
(Notes in bold and color added by KCE)

The transverse W8x31 beams of the "jacking" towers were resting in the U-head on top of the screw jack of the shoring tower. The longitudinal W8x31 Jacking beam was connected to the transverse W8x31 beams with a bolted connection. The longitudinal W8x10's on top of the "jacking" tower were set loose in the head.

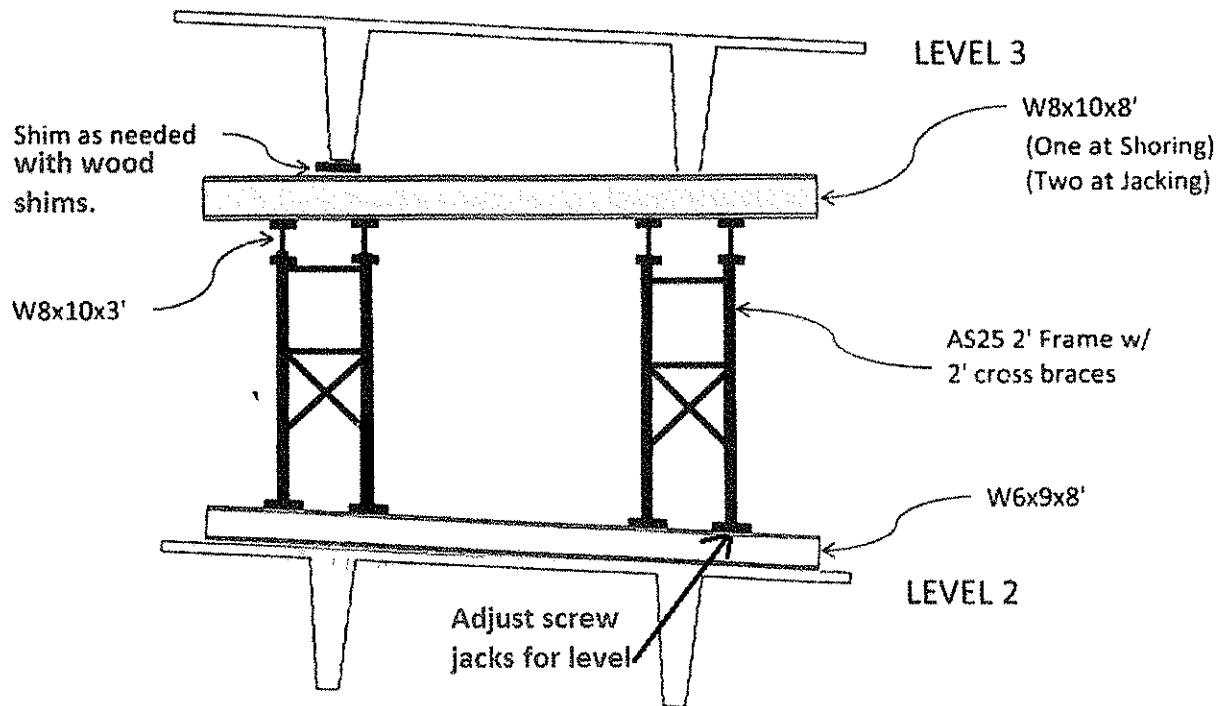
Figure 5 - WT Drawing Sheet J3 dated 05-05-13: Section of Safety Tower Configuration
(Notes in blue and color added by KCE.)

The transverse W8x10's of the "safety" towers were supported in the U-head on top of the screw jack of the shoring tower with C clamps on some, but not all, heads. The longitudinal W8x10 was resting loose across the transverse W8x10's.

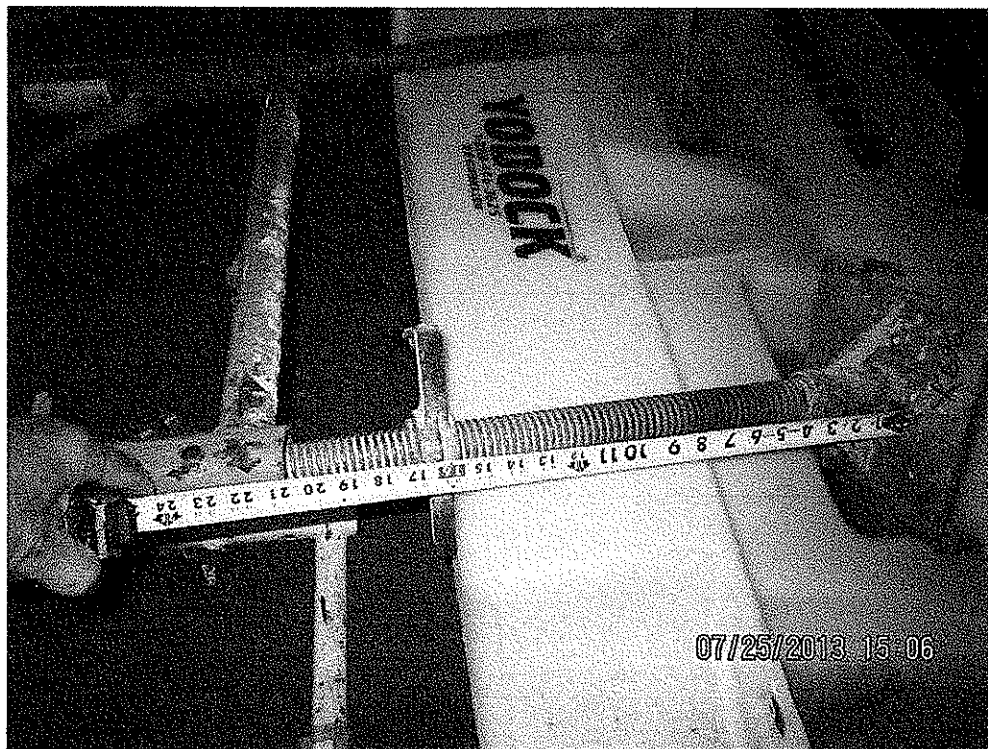
Picture 3 - Extension of "Jacking" Tower Frame Base > 12"

The "jacking" tower scaffold legs were extended beyond manufacturer recommendations and extension sections were not braced per manufacturer requirements, which each reduced their load carrying capacity.

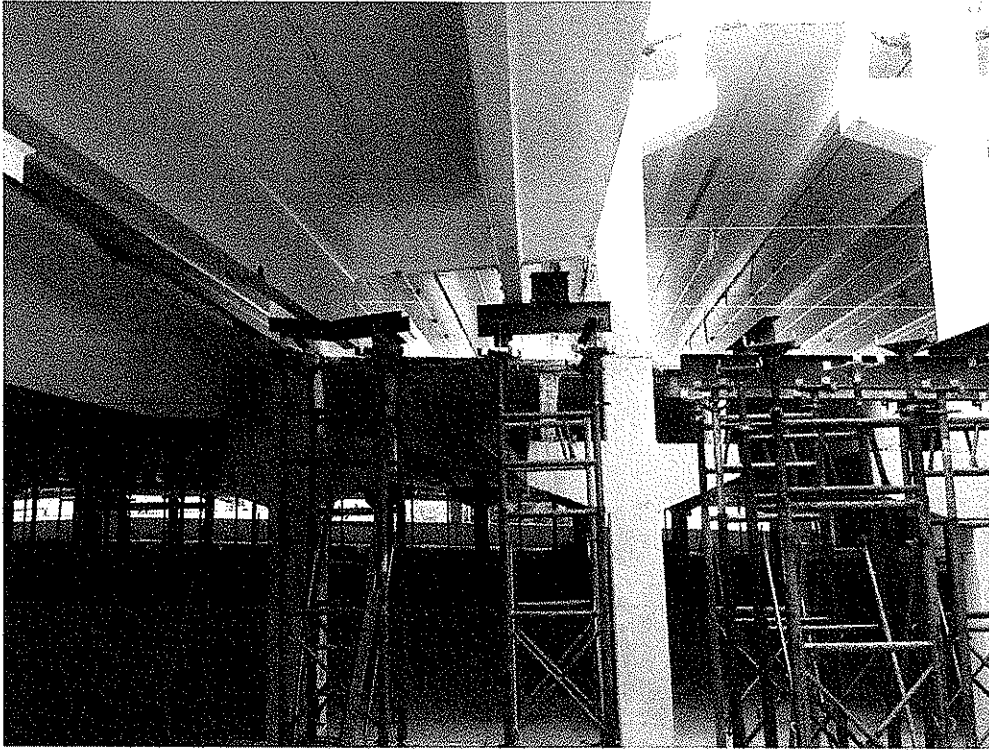
Picture 4 - North End "Safety" Towers of Partially Collapsed Tee

Based on the site photographs we took upon arrival, the as-designed shoring tower layout may not have been adhered to throughout. As can be seen in Picture 4 two smaller individual W8x10

beams are spanning the shoring towers in the longitudinal direction as opposed to the continuous 8' W8x10 spanning both 2'x2' Adjust-A-Shore® framing towers as shown on WT drawings J1-J5.

The "safety" towers under the partially collapsed tee were not installed per WT sheets J1-J5 dated 05/05/13 or sheets P1 and P2 dated 05/06/13. The continuous W8x31 jacking beam was not placed spanning the two "jacking" towers but rather two separate beams were used. (Having two separate longitudinal beams allows each individual 2'x2' AS25 Adjust-A-Shore shoring tower to be moved and placed independently of each other and extended to different heights for construction adjustment.)

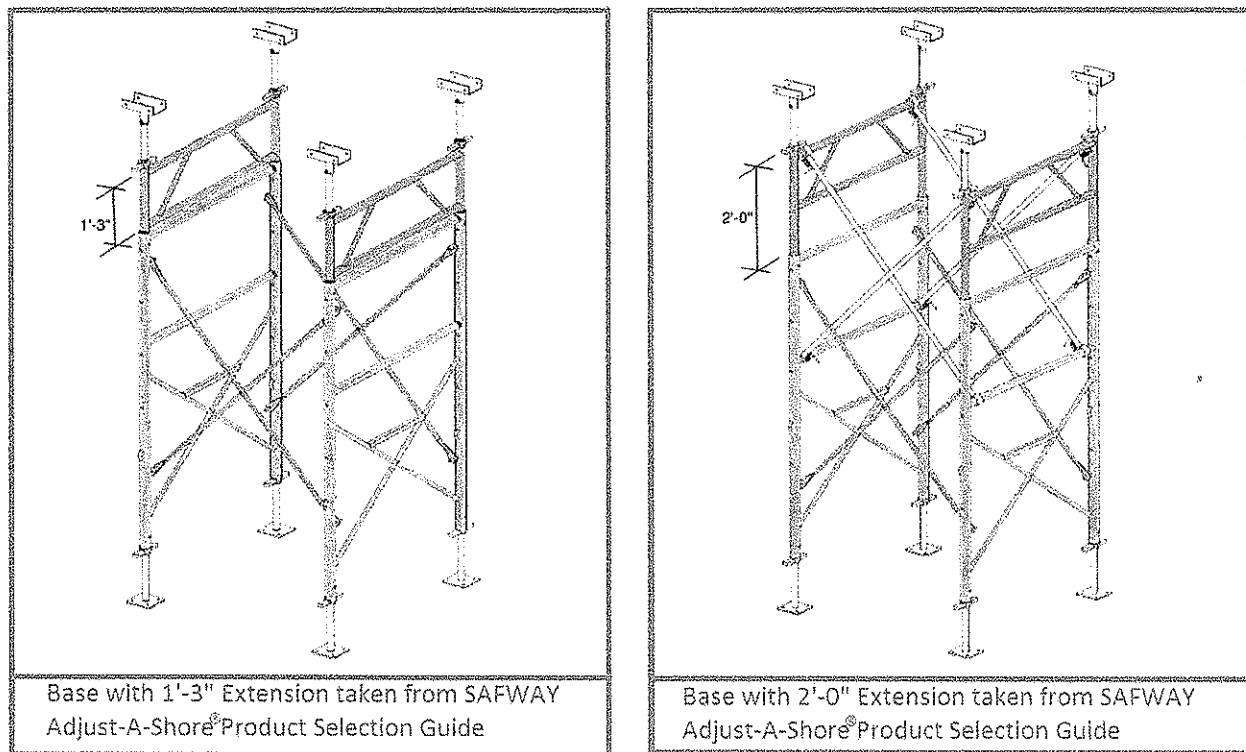
Figure 7 - SAFWAY Bracing Configurations for Extended Frames (colors added by KCE)

The SAFWAY Adjust-A-Shore® Product Selection Guide notes that AS24 extension frames can be used to extend the height of AS25 Base Frames. When the height of extension is 2' or greater additional diagonal gooser (cross) braces are needed (See Figure 7 above, which indicates the configuration of a 2' extension with the required gooser braces (shown in yellow)). It also indicates the configuration for a 1'-3" extension when no additional bracing is required. The towers on site have the AS24 extension frames. Additional extension of the "jacking" towers was accomplished with the screw jack extensions. The "safety" towers did, however, utilize the AS24 extension frames with a 2'-0 extension but no gooser bracing was installed.

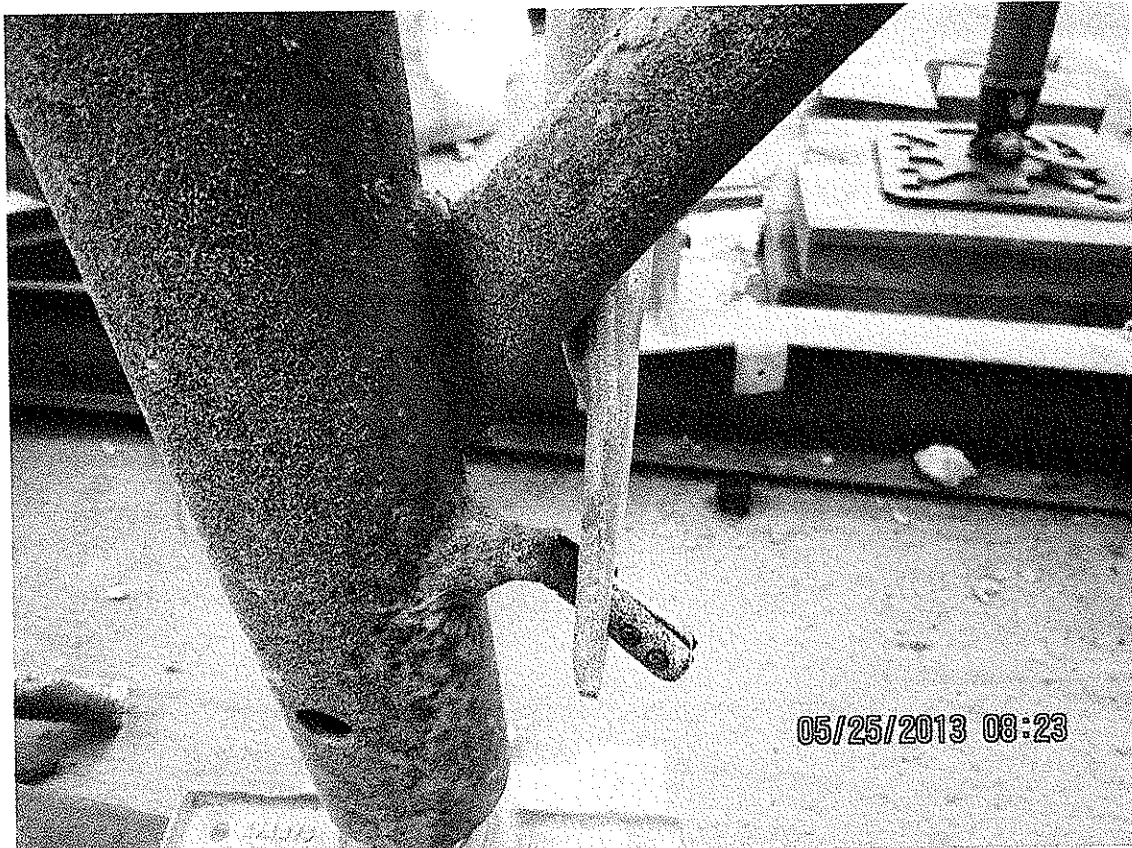
Picture 6 - Connection pin of base frame

Whenever a load is applied at an angle to an element, the load is resolved into a vertical force and a horizontal force. If the tee was being jacked unevenly, it resulted in the tee being at an angle in the North-South direction, and, due to the ramp slope, in the East-West direction, a horizontal force would be introduced to the shoring towers. Without the bracing in the extension frames and no lateral bracing between the towers, additional movement is likely to occur and more force is likely to be introduced into the intra-tower cross bracing. It can be seen in many locations that the connection pins for the braces were in fact sheared and/or bent (Picture 6). The cross bracing buckled and the base tower legs split at the interface with the male extension section inside the female base tower leg.
